Ultrasonic Inspection of the LTAB Floor

Graham Thomas

July 31, 2001

Lawrence
Livermore
National
Laboratory

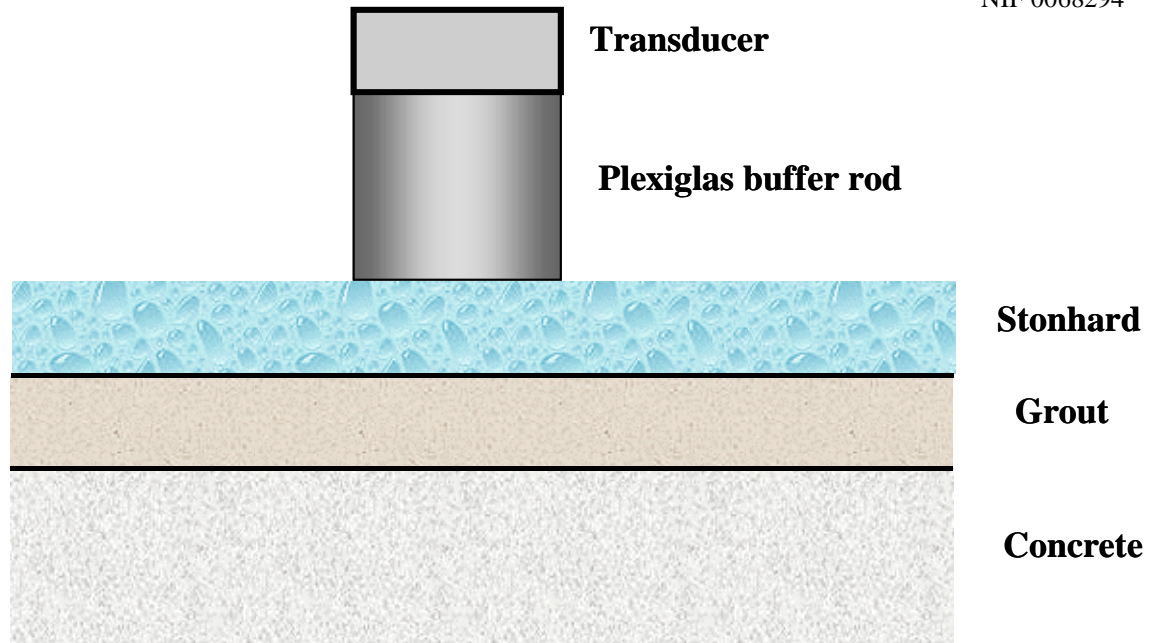
Figure 1. A cross-sectional view of NIF floor with ultrasonic transducer on a Plexiglas buffer rod. The buffer rod allows us to capture a surface reflection from the buffer rod to floor interface that acts as a reference signal. We also capture reflections from the Stonhard-to-grout interface and the grout to concrete interface. The grout layer must be intact for the ultrasonic energy to propagate through it and reflect off the grout to concrete interface.

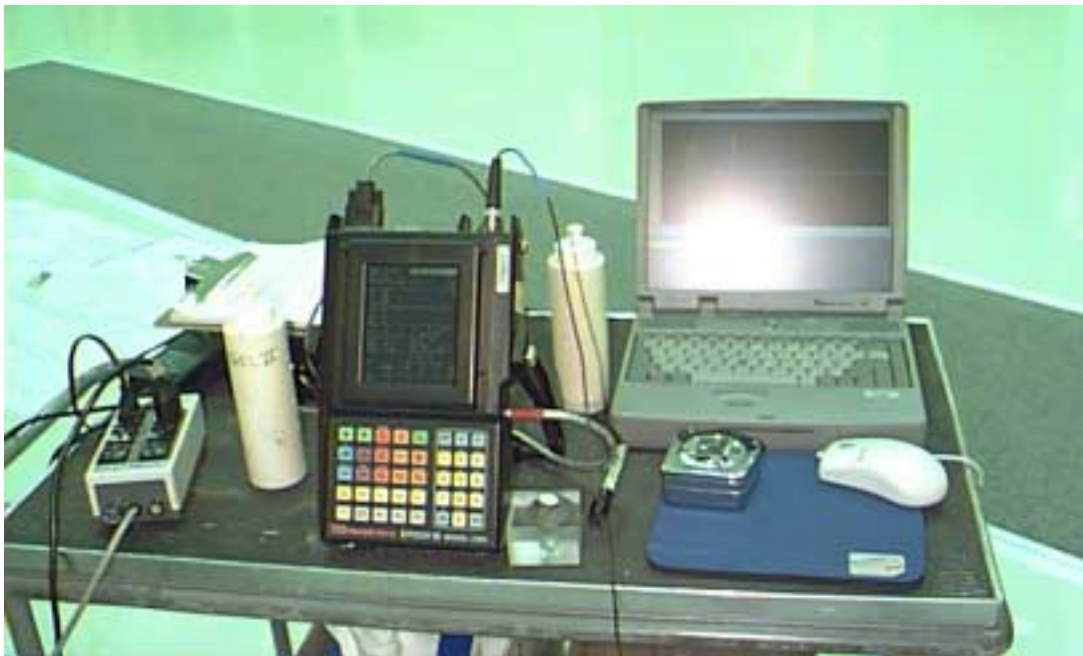
Figure 2a. Photograph of the portable ultrasonic data acquisition system. The ultrasonic data was captured on a laptop computer for analysis.

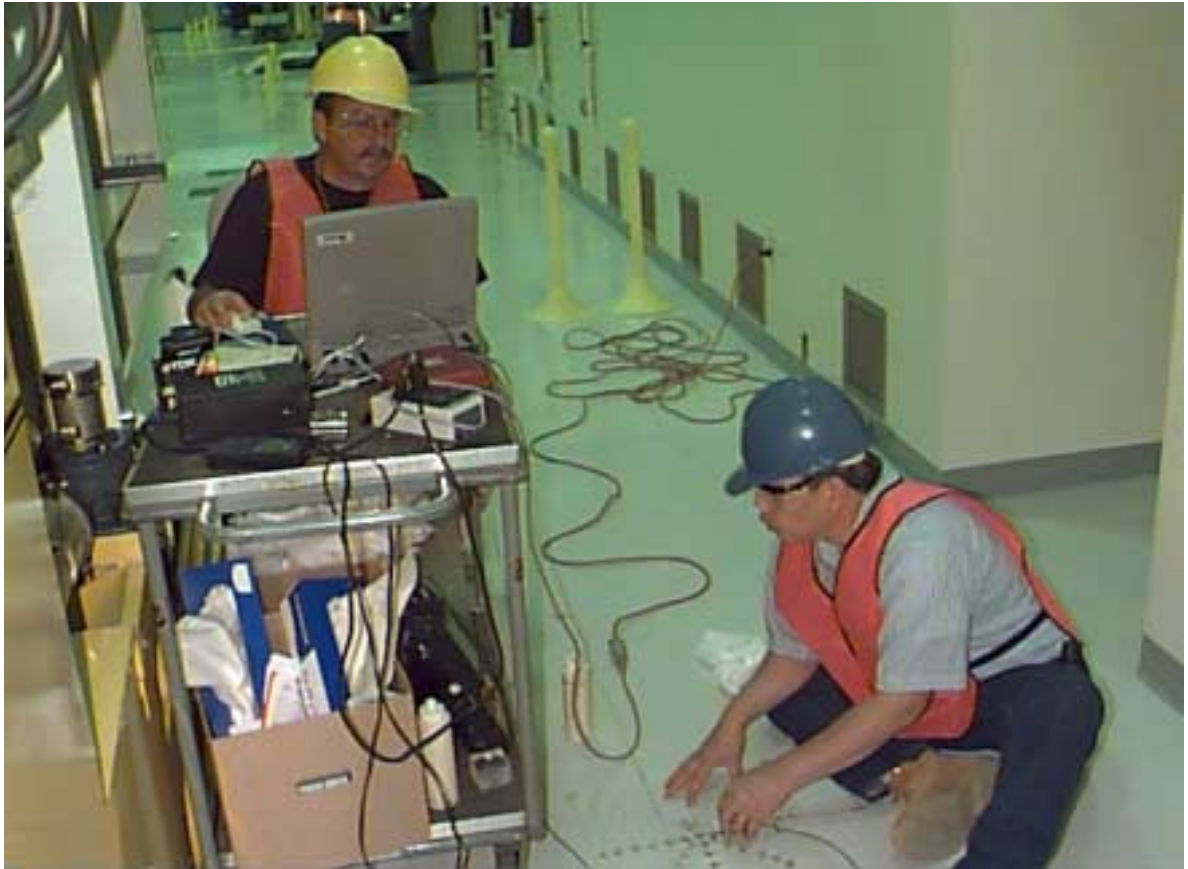
Figure 2b. Photograph of ultrasonic data acquisition on NIF's floor.
